KEEP STORAGE BAY DRY

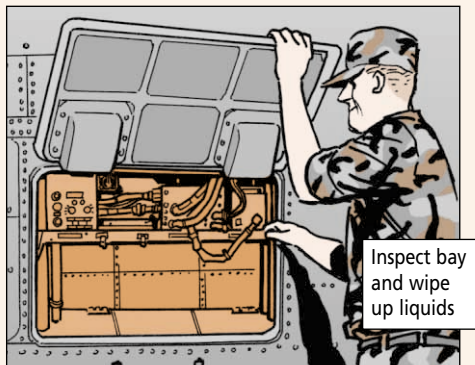
That's because on the A model the cable harnesses for those components are routed through holes at stations 285 and 305—now called the left aft avionics bay—which cannot be sealed. So rain water, wash water, condensation and even hydraulic fluid can enter the bay, following the cable bundles. It then leaks onto the avionics. Because the digital processor sits on the shelf, it allows water to wick in from underneath.

Change 1 to the MWO will raise the processor off the shelf to keep water from getting underneath.

But until the headshed comes up with a permanent fix for the leaky bay, take extra care not to direct water at the ventilation holes which help cool the avionics bay. Then inspect the bay for water and corrosion after you wash your bird or fly in the rain. Mop up any liquid on the avionics and the mounting area with a clean cloth and treat any corrosion you find.
